# Manhole Inspection Summary

Manhole # S29Q\_\_016MH

Insp Date: **11/16/08 11:53 AM**

**Location** Address: **1238 W Ostend**

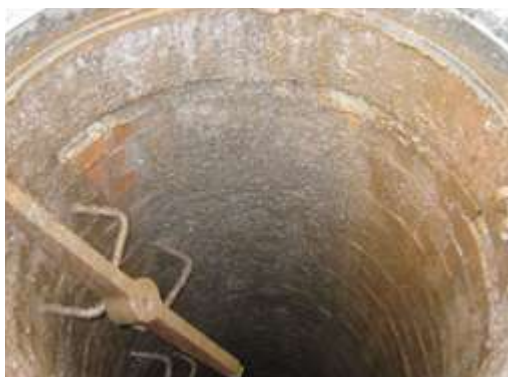
Defect 1

frame/lid infiltration

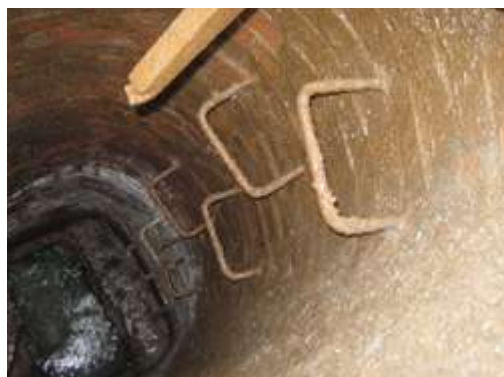
Defect 2

oxidized rungs / frame/barrel infiltration

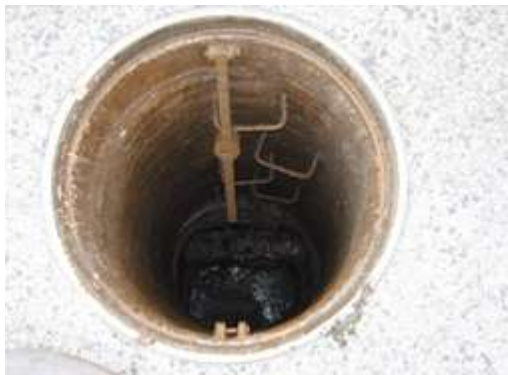
### Defect 3

frame leaks

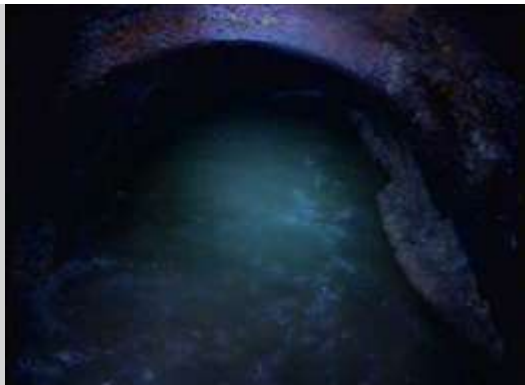
6 O'Clock Inflow

Pipe Height: **25.2** (in.) Rod and Bar (Angled)  
Pipe Material: **Clay** ☐ Pipe Lined  
Invert Depth: **17.15** (ft.) Flow Characteristics: **Fast**  
Deposits: ☐ None ☒ **Mud** ☒ **Sludge** ☐ Debris ☐ Grease  
Silt Depth: **4** (in.) Deposits Extent: **Medium**  
Infiltration: **None** Pipe Seal Cond: **Sound**
